Shear Strengthening of RC Deep Beams with Symmetrically or Asymmetrically Positioned Square Openings Using CFRP Composites and Steel Protective Frames

^{1*} Soumya Ranjan Satapathy, ²Sipi Sanom Das

^{1*} Assistant Professor, Dept. Of Civil Engineering, NIT BBSR,

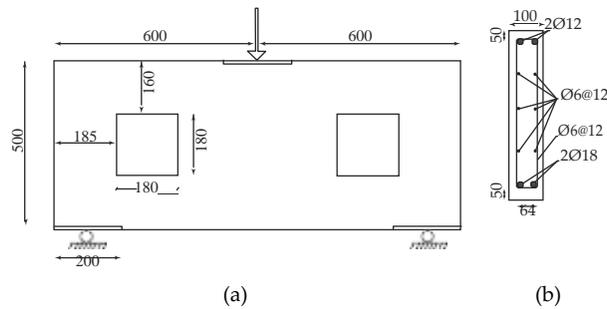
Figure 1: Reinforcement details (dimensions in mm).

Preparation of Specimens. For this study, 11 deep RC beams (each 120 cm in length, 50 cm in height, and 10 cm in width with net spans of 100 cm and identical strengths) were uniformly constructed and subjected to the three-point monotonic bending test. The specimens were different in their retrofitting arrangements and openings position. For each specimen, three steel plates of identical thickness were used at the loading and support points to prevent plate bearing failure. To determine the effects of plate thickness at loading and support points, two control specimens were also constructed, one with a plate 15 mm thickness and the other similar to the experimental ones with a plate 30 mm thickness. Stress concentration at support and loading points in the beams was prevented by welding two U-shaped $\Phi 12$ steel bars to the steel loading plates. All the plates were installed in the mold before concrete pouring. Reinforce- ment used in the beams complied with ACI 318 [23] (Figure 1(a)). Table 1 reports the mechanical properties of the steel rebars used in the test.

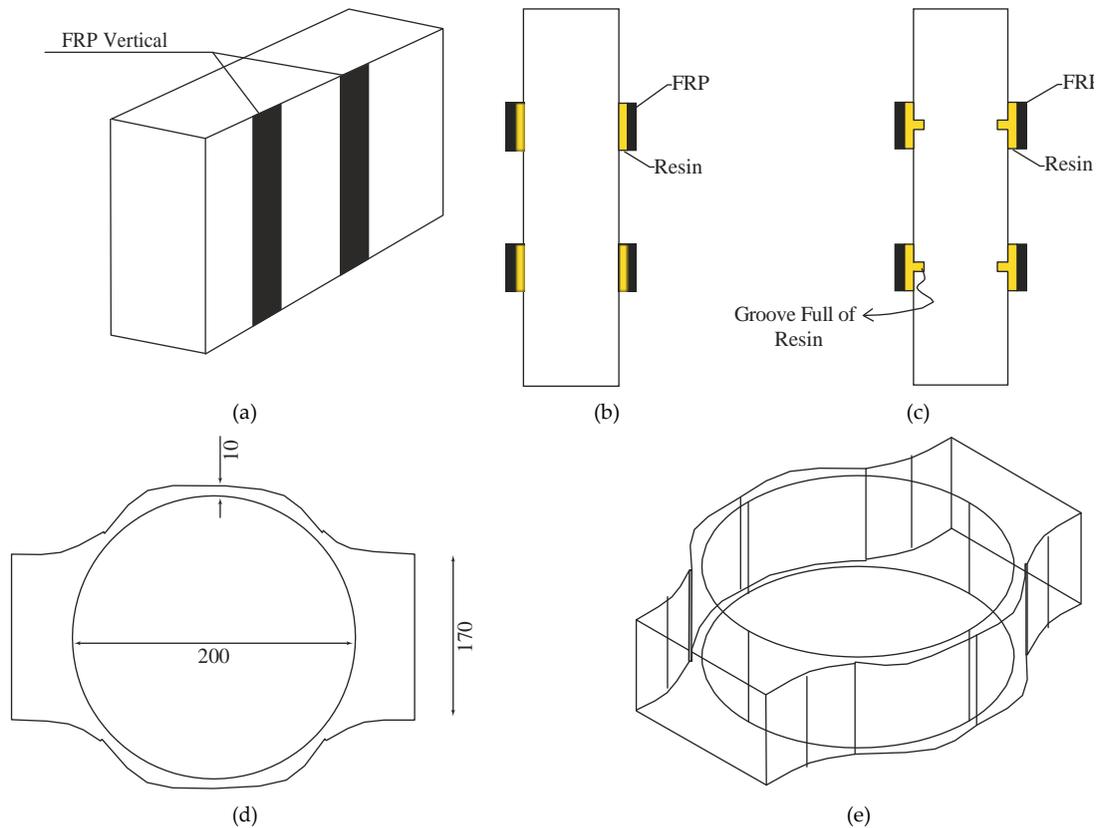
FIGURE 2: Schematic representation of FRP installation via the EBR and EBROG techniques as well as that of steel frames: (a) vertical strengthening of a beam via the EBR or EBROG technique; (b) EBR; (c) EBROG; (d) 2D plane of a steel frame (dimensions in mm); and (e) 3D plane of a steel frame. *Note: the resin, fiber, and groove dimensions are far larger than their real size.

While the EBR technique involves installing the CFRP sheets directly on the concrete surface via the wet layup method, the EBROG technique begins with an initial step of making grooves about 10 mm in both width and depth in the concrete where the FRP strips are installed. This step is followed by filling the grooves with adequate resin. Figure 2 shows schematically the procedures for FRP installation in both EBR and EBROG techniques. All the retrofits were 5 cm in width; however, those used in specimen strengthened with FRP wraps that extended to the openings were 8 cm in width. In case the FRP sheets were discontinued, the retrofits would be extended to the concrete surface and opening edges to cover lengths of 5 cm of the upper and lower surfaces to provide complete confinement and to prevent early debonding. In the specimens strengthened with SPFs, steel frames of a height equal to the specimen's width (with openings prefabricated in them to serve as expected beam openings) were initially constructed and fixed in place within the mold before concrete casting such that the frame would be embedded in concrete (Figures 2(d), 2(e), 3(g), and 3(h)). The SPFs in this experiment were used to determine whether load transfer would occur on one or both sides of the frame. Hence, a frame thickness of 25 mm was selected at its most critical zone (i.e., the arch) so that it would not fail under loading. Additionally, the inside of the frame shown in Figure 2 that is circular plays no role in the load transfer process. This property can be replicated in square openings so that the frame looks square-shaped from the inside but

circular from the outside. The external circular shape was adopted to avoid extreme stress concentration in the corners of square frames.

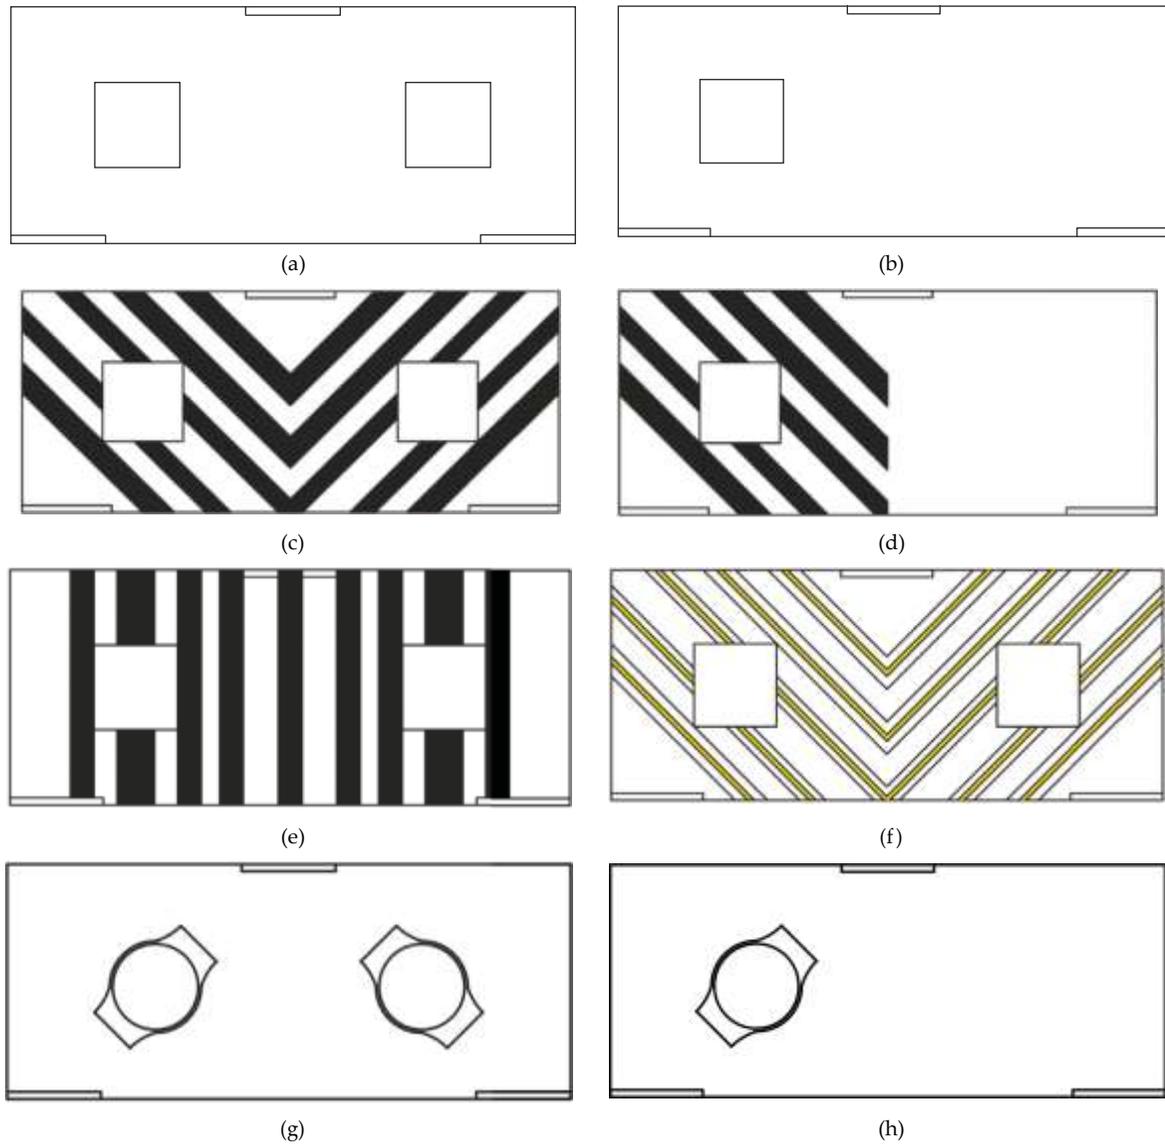
Figure 3: FRP-strengthening configuration in specimens: (a) specimen "S"; (b) specimen "E"; (c) specimens "S-EBR"; (d) specimen "E-EBR"; (e) specimen "S-W"; (f) grooves in specimen "S-EBROG"; (g) specimen "S-F"; and (h) specimen "E-F."

The square openings created were 18 cm on each side and distributed either symmetrically or asymmetrically along the beam so that they would cut across a large part of each stress path. The symmetrically positioned openings are shown in Figure 1(b), and only one of the asymmetrical openings remained in its original position.

technique (EBR or EBROG) used, and the letters *W* and *F* standing for wrapping and SPF, respectively. Figure 3 presents the different strengthening methods and opening positions in the specimens.

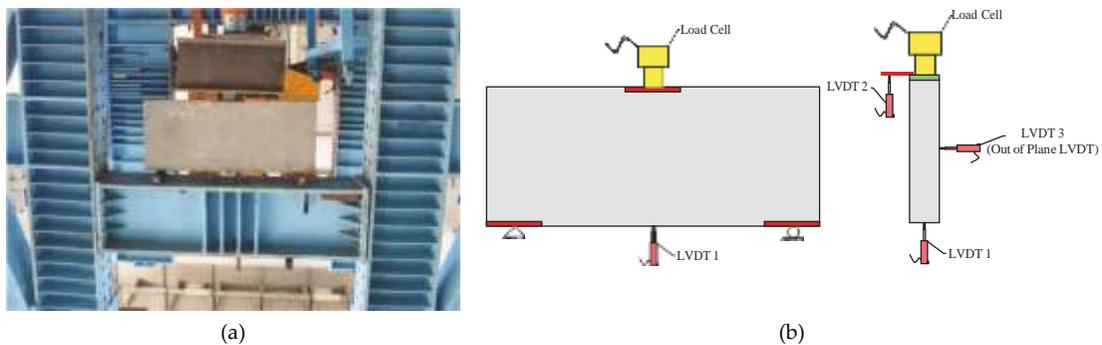
Figure 4: Test setup: (a) loading FRAME; (b) schematic representation of LVDTs and load cell installation (main and lateral sides).

Test Method. A steel frame as shown in Figure 4(a) was used to implement the three-point flexural loading. Displacements were recorded using three LVDTs, one load cell, and one data logger. Two of the LVDTs were installed in the center of the upper and lower sides of the specimen to measure displacement, while one was also mounted perpendicular to the vertical sides of the beam to monitor any out-of-plane displacements. Loading was applied under displacement control using a hydraulic pump, while the applied load was measured using a load cell. Figure 4(b) presents a schematic view of the test setup.

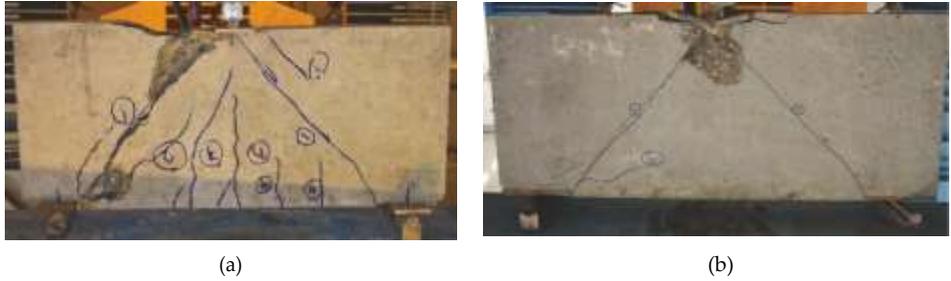
Figure 5: Failure modes of control specimens: (a) C1 and (b) C2.

Failure Modes of the Specimens. Figures 5(a) and 5(b) depict the failure modes of C1 and C2. As already mentioned, these specimens only differed in their loading plate thickness. As reported in most previous studies experimenting with similar specimens [25–30], specimen C1 with a loading plate thickness of 30 mm exhibited diagonal cracks initiating from the inner edges of the supports that further extended to the loading plate. These cracks later grew in width as loading proceeded up to the failure point. Although the concrete around the loading plate

with a loading plate thickness of 15 mm, which gradually widened as loading proceeded and bending of the loading plate increased. The specimen ultimately failed after the loading plate had undergone enough bending, and the concrete experienced a complete local failure. As shown in Figure 5(b), this was accompanied by widespread cracking and fracturing of concrete in the areas around the loading plate. Therefore, it may be claimed that inadequate thickness of the loading plate caused the failure mode of this specimen to change from diagonal to local failure. Also, it may be mentioned that local failure is a premature failure in which the specimen fails to exploit its full strength.

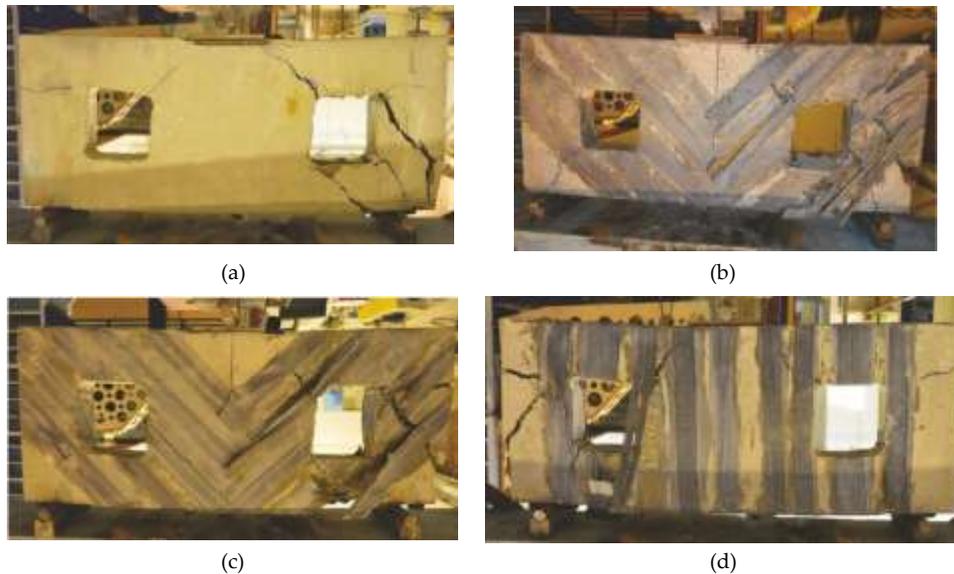
FIGURE 6: Failure modes of specimens with symmetrically positioned openings: (a) specimen *S*, (b) specimen *S-EBR*, (c) specimen *S-EBROG*, and (d) specimen *S-W*.

In specimen "S" (Figure 6(a)), the first cracks formed about 35–40% of the maximum load. These cracks initiated from the corners of the opening toward the support point and later increased in number, while separate cracks also started to appear from each corner of the opening and propagated toward the loading and support points as loading proceeded. This observation confirms those reported in Kong [28]. It is observed in this figure that the cracks propagated symmetrically on both sides of the beam up to high loading levels (near the failure point) but that ultimate failure occurred when those on one side of the beam had already widened. The reason underlying the diagonal cracking pattern observed in all the specimens with openings is the tendency of the forces to transit from the loading to the support point over the shortest possible path; in beams without openings, the shortest path is a direct line between the support and the loading plates while the shortest path in

loading process due to the high impact of the FRP sheets as a result of the grooves, which ultimately caused big pieces of the substrate concrete to spall. Compared to the specimens lacking grooves, these specimens had more ruptured FRP sheets mostly on large cracks. However, most of the FRP sheets underwent a debonding failure accompanied by the spalling of big pieces of the substrate concrete. This failure mode may be attributed to the good shear strength created between the FRP retrofits and the substrate concrete due to the grooves (Figures 6(c) and 7(c)).

The cracking behavior in specimen "S-W" was similar to the other specimens. Cracks started from the corners of the openings and propagated toward the support and loading points, which transferred considerable amounts of the forces to the substrate concrete due to the confinement resulting from the FRP sheets wrapped around the specimens. This sequence of events finally caused great cracks to appear, and pieces of concrete to spall. Although some of the FRP sheets ruptured because of their location at the sharp edges of the beam section, no FRP debonding was observed in this specimen due to the adequate anchorage of FRP retrofits (Figure 6(d)).

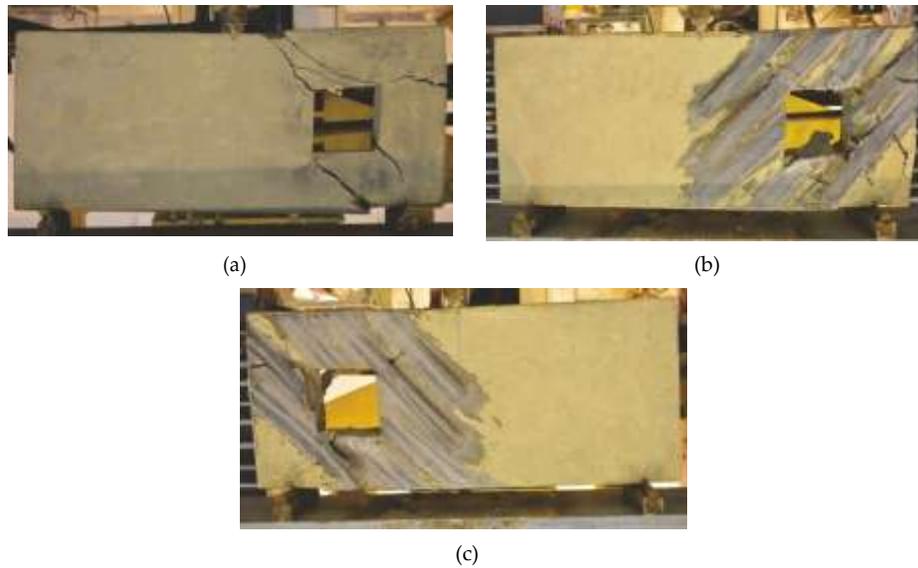
FIGURE 7: Failure modes of specimens with asymmetrically positioned openings: (a) specimen *E*, (b) specimen *E-EBR*, and (c) specimen *E-EBROG*.

Although a cracking pattern similar to that in specimen "S" was observed on the side enclosing the opening in the specimen with asymmetrically positioned openings (i.e., specimen *E*), its other side with no openings exhibited much smaller cracks. This was attributed to the strength of the nonopening side that was much higher than that of the side with openings. The higher strength of the nonopening side also led to its lower contribution to the final failure of the beam (Figure 7(a)).

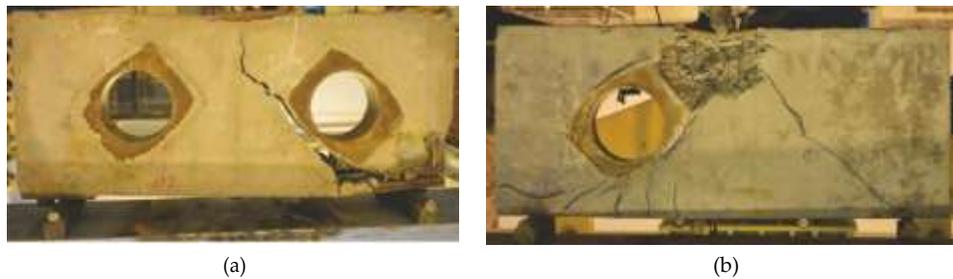
Figure 8: Failure modes of specimens strengthened with SPFs: (a) specimen *S-F* and (b) specimen *E-F*.

There is a high tendency for trusses to form in specimen "C-F" due to the SPFs installed (Figure 8(a)). However, the heterogeneity of concrete and steel as well as the inadequacy of the shear strength between the frame and the concrete caused the SPF to detach from the concrete on one side, and the loads were diagonally transferred to the support point. It should be noted that forces are transmitted to the support points through SPF. It subsequently causes the width and the amounts of cracks to be decreased. If lateral stresses are ignored and only axial forces are taken into account, the SPF can then be viewed as a "two-force member" that transfers the forces axially without diverting their path. Given the spalling of the concrete surrounding

the frame, it seems logical to hypothesize that lateral forces did not affect the frame. Nevertheless, mechanical joints around the frame can be used to ensure SPF-concrete continuity. In this situation, steel bars or mechanical ribs connected to the SPF can be used as joints that, when embedded sufficiently deep in concrete, will yield the desired connectivity between the frame and the concrete to prevent the detachment of the SPF from the concrete bulk. Despite the better truss performance of SPFs due to their being unaffected by lateral stresses, the technique is handicapped due to the frame-concrete discontinuity. The discontinuity between the frame and concrete has a decreasing effect on the structural performance of beams. This calls for further research to resolve this problem and to shed more light on the advantages and drawbacks of SPFs from a different perspective. In addition to the above, the high loads applied to the support and the stress concentration in concrete due to the presence of an SPF caused the concrete around the support point to spall, whereas the spalling had no notable effects on reducing final load-bearing capacity in the absence of large cracks.

Specimens “*E-F*” and “*C-F*” were similar not only in the behavior of their SPF retrofits but also in the debonding of

their SPFs (Figure 8(b)). However, "E-F" exhibited differences in two essential respects; the first difference was the diagonal cracking in its side lacking openings, which is reasonably expected; and the second was its premature failure due to high-stress concentration in the concrete around the loading point. As shown in Figure 8(b), the concrete beneath the plate failed due to the bending of the loading plate, which led to the ultimate failure of the specimen. Even though this specimen does not provide much substance for predicting its loading capacity, the SPF's positive role in load transfer cannot be denied as judged from the cracking pattern around the SPF.

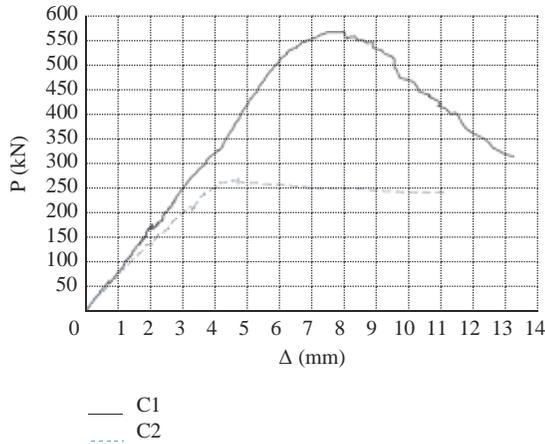
Figure 9: Load-displacement curves of the control specimens.

Effects of Loading Plate Thickness. Figure 9 presents the load-displacement curves for specimens "C1" and "C2." It is seen that the two curves are similar as far as their initial slopes are concerned. However, the loading plate in specimen "C2" bends due to its low thickness and that its displacement is larger than that of the control due to the bending. Hence, the term " Δ " in the curve begins to rise. The specimen reaches its maximum loading of 267 kN at a displacement of 4.73 mm, beyond which displacement rose

with a constant slope of near-zero until a displacement of 11.20 mm as its ultimate loading was reached when the specimen failed. The near-zero slope observed in the second region of the curve for specimen “C2” indicates the predominant contribution of the loading plate behavior to the failure mode of the specimen. In contrast, the curve for specimen “C1” with an adequate plate thickness exhibits a slope steadily rising to its maximum loading of 565 kN for a corresponding displacement of 7.84 mm, which is higher than those of C2. Moreover, it is seen that the specimen exhibits a behavior characteristic of reinforced concrete structures in that it reaches its final state with its curve descending in a ductile manner after it reaches its maximum loading. Comparisons of the curves in Figure 8 and the displacement values reported in Table 2 reveal the greater displacement of “C2” than that of C1 since its behavior in the final loading stage is similar to that of steel. In terms of bearing capacity and energy absorption, however, C2 recorded values by 48% and 68%, respectively, lower than those of specimen “C1.” The high decreases in these values indicate the important effects of loading plate thickness and, thereby, stress concentration on the load-bearing capacity of structural elements. Based on the above considerations and due to the premature failure of “C2,” specimen “C1” was used as the control.

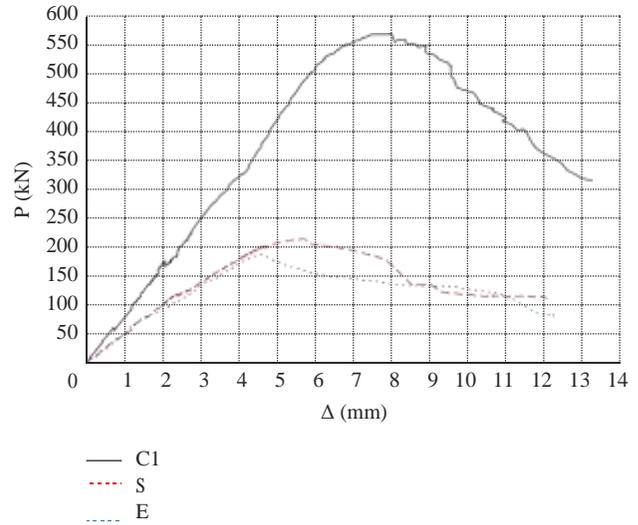
Figure 10: Load-displacement curves of the nonstrengthened asymmetrically positioned square openings causes great decreases in beam stiffness. As shown in Figure 10, however, there is no linear relationship between the number of openings and the

Effects of Opening. The load-displacement curves in Figure 10 derived for the three nonstrengthened specimens were used to investigate the effects of openings in deep beams. The first point to note in these curves is the differences among their initial slopes. The openings in these specimens intercept the stress transfer paths and, thereby, lead to drastic reductions in stiffness. Generally speaking, as a result of the high effects of stress transfer path dimensions on beam stiffness, any weak or defective zones in this path lead to the reduced overall stiffness of the member. Therefore, the presence of symmetrically or

reduction in stiffness such that increasing the number of openings does not necessarily lead to further decreases in stiffness beyond a certain level. The reason for this might be sought in the instability of determinate trusses, in which instability is caused by decreasing degrees of freedom (to any level). In other words, the removal of only one member of the determinate truss suffices to make it unstable. Since the present deep beams are modeled as determinate trusses, removal of any number of members in them will have the same invariable effects. In other words, creating an opening and the resultant diversion in the stress transfer path can be interpreted as a kind of truss destabilization that is not affected by the number of openings made although the extent of instability of a beam with an opening in it is less than that of a beam without a strut. Thus, the destabilization effects can be used to determine the level of stiffness in-variability. The higher the effects of an opening on the stress transfer path, the higher the effects of instability. Several factors are involved in beam instability, the most important of which are opening shape, dimensions, and position. For extremely low effects of opening on beam load capacity, beams will exhibit different behaviors depending on opening symmetry. However, if the presence of an opening causes great reductions in beam load capacity, the effects of opening symmetry will be negligible, and the beams with either symmetrically or asymmetrically positioned openings will exhibit the same behavior since the beam tends toward greater instability. This is partly verified by comparing the load-bearing capacities recorded for the two types of specimens. Defective or weak zones in stress transfer paths act as removed truss members that lead to reductions in the load-bearing capacity of the truss. Hence, the specimen with symmetrically positioned openings (S) reached its maximum load capacity of 213 kN at a displacement of 5.58 mm, representing a reduction of 62% in load capacity and 68% in energy absorption in comparison with the control specimen. The same values for the specimen with asymmetrically

positioned openings were 187 kN and 4.56 mm, respectively, showing reductions of 67% and 81% relative to those of the control. Thus, it is observed that both kinds of symmetrically and asymmetrically positioned square openings in the stress transfer path caused notable decreases in load-bearing capacity, energy absorption, and stiffness with no significant differences between the two types of openings. Finally, the relevant curve shows that the ultimate load was reached with a gradually declining slope after the maximum load had been reached.

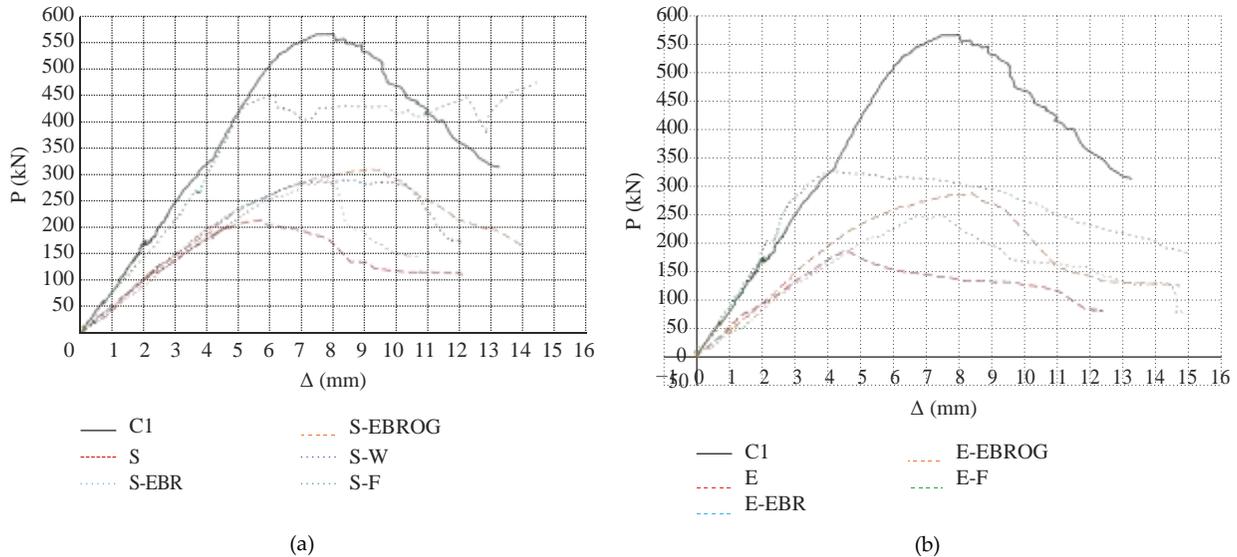
FIGURE 11: Load-displacement curves of the strengthened specimens: (a) specimens with symmetrically positioned openings and (b) specimens with asymmetrically positioned openings.

Effects of Strengthening Method. The diagrams in Figure 11 represent the behaviors of the specimens with either symmetrically or asymmetrically positioned openings. The strengthening methods used in these specimens include using CFRP composites with the EBR or EBROG techniques and using SPF.

The EBR Technique. The three specimens S-EBR, E-EBR, and S-W were retrofitted via the EBR technique. Figure 11 presents their load-displacement curves. It is observed that the curves of these three specimens exhibit initial slopes similar to those of the corresponding non-strengthened ones. This is observed in all the specimens strengthened with FRP retrofits (via either the EBR or the EBROG technique). The identity of the initial slopes may be attributed to the way FRP sheets carry loads; for FRP sheets to be loaded in a specimen, at least one crack must have appeared in the concrete surface so that tensile stresses from the concrete would be transferred to the FRP retrofits. Since cracking in concrete

The EBROG Technique. The two specimens "S-EBROG" and "E-EBROG" were used to investigate the effects of grooves used in the EBROG technique; the relevant load-displacement curves are presented in Figure 11. As already mentioned, FRP debonding is one of the principal failure modes, which takes place in the top side of ordinary beams (flexural strengthening) and the Web of deep beams (shear strengthening). The reason for debonding of FRP sheets in this technique is inadequate anchorage for them. The grooves made in the EBROG technique transfer more forces to the inner layers of concrete and, thereby, give rise to better adhesion of the retrofits to the substrate concrete. This, in turn, leads to an enhanced shear strength that delays the debonding event. Despite its widespread use in ordinary beams [18–20], application of the grooving technique in deep beams was only reported in Arabzadeh and Karimzadeh [8] who used grooves to strengthen deep beams with circular openings.

It is seen in Figure 11 that specimen "S-EBROG" reached its maximum loading of 310 kN at a displacement of 9.13 mm beyond which ultimate load was achieved with a falling slope in a ductile manner as already observed with other specimens. According to Table 2, increasing load-bearing capacity in this technique was almost similar to those in specimens without grooves but energy absorption increased by about 60%. Moreover, this specimen recorded

The SPF Technique. The load-displacement curves for specimens "S-F" and "E-F" are presented in Figures 11(a) and 11(b), respectively. It is observed that these curves exhibit initial slopes different from those of specimens strengthened with FRP retrofits. Two important notes may be mentioned for the differences observed. First, FRP retrofits, as already observed above, are activated to participate in load-bearing at loads equal to 70% to 80% maximum load. Hence, the initial slopes in the curves for the specimens thus strengthened are reasonably expected to correspond to those of the nonstrengthened ones. Unlike FRP retrofits, however, SPFs contribute to the load-bearing capacity from the very beginning of the loading process as a steel member is placed at the position of the opening; this naturally affects the initial slope of the curve. The second note is the stiffness of the specimens strengthened with SPFs is almost similar to that of the control specimen ("C1"). The replacement of a steel frame for the opening not only helps maintain the basic role of the opening to accommodate installations but also compensates for the low strength due to breakage of the strut. In other words, rather than transferring the loads through the medium of concrete, they are transferred directly through a steel frame that serves as a two-force member. Therefore, it is natural that far fewer declines are observed in such structural properties as stiffness and loading capacity. According to Figure 11(a) and Table 2, specimen "S-F" reached its maximum load of 473 kN at a displacement of 14.49 mm. This means a 19% decrease in loading capacity relative to that of specimen "C1" but a 115% increase relative to that measured for "S."

Experiencing a premature failure, specimen "E-F" reached its maximum load of 326 kN at a displacement of 4.25 mm, showing a reduction of 42% in load-bearing capacity when compared to "C1" but a 73% increase relative "E." Beyond the maximum load, the specimen "S-F" reached its ultimate load value, realized by a relatively horizontal line accompanied by great fluctuations in the curve. This behavior indicates the intense interlock of concrete and steel frame, the loss of which caused a sharp drop in loading capacity followed by rising segments before the next interlock. This process repeated itself several times before the ultimate load was finally reached. This behavior was not observed in "E-F" that exhibited behavior similar to that observed in strengthened specimens. That is, after reaching the maximum load, its curve declined in a ductile manner before it reached its ultimate load. These differences between the behaviors of "E-F" and "S-F" for load capacity and postpeak behavior could have been due to both premature failures of "E-F" and the positional symmetry of their openings. Since steel frames are much stronger and stiffer than concrete, specimen "S-F" with two frames tends to exhibit a nonconcrete behavior. Rather than a falling curve characteristic of a concrete member, it has a horizontal curve
